RANS

Operational Alert: 162

Subject: Aileron Link Cables and Turnbuckle

Models Affected: All S-7LS and S-7S models

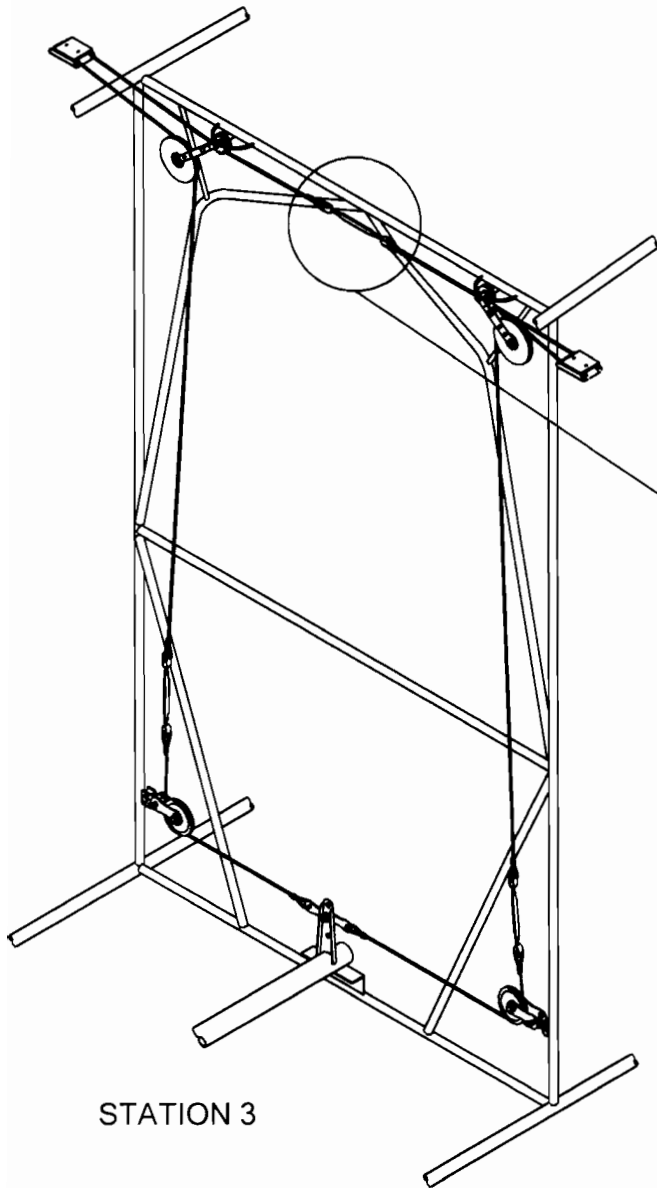
STATION 3

During assembly of an aircraft at the factory, we noted that only 4 threads could be engaged on the upper Turnbuckle at Station 3 (connecting Aileron Link Cables). Investigation showed that some Aileron Link Cables have been made too short.

6 TURNS MINIMUM
ENGAGEMENT

Prior to the next flight, inspect upper Turnbuckle at Station 3 for thread engagement (Reference attached drawing).

A minimum of 6 threads should be engaged on each end of the Turnbuckle.

If this cannot be assured, change Turnbuckle to part # RL-335-BT. Turnbuckle RL-335-BT is slightly longer and available from RANS Parts Department.

TURNBUCKLE IS RL-335-AT
CHANGE TO RL-335-BT
IF REQUIRED.
