Airworthiness Directive: 136

Date: May 14, 2010

Subject: Hour meter oil pressure switch leak

Models Affected: All RANS aircraft with ROTAX 912 engines equipped with an oil pressure switch for hour meter

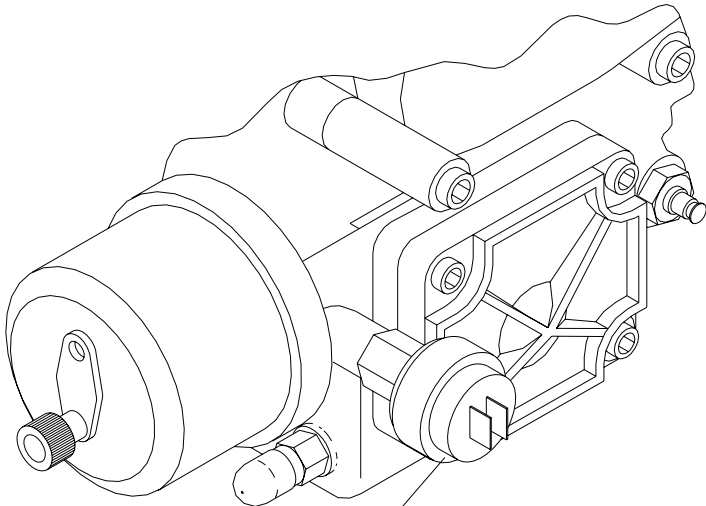
Inspection Location:

It has been brought to our attention that failures have occurred in the internal seal of the Oil Pressure Switch (RANS P/N KSES0004). This has caused premature loss of oil resulting in engine failure.

INSPECT FOR OIL LEAK HERE

Inspect for leaks before next flight. If leaks or defects are found, remove the aircraft from service until it is possible to replace the oil pressure switch with a 1/8" pipe plug and install Hour Meter Relay Assembly.

Option 1 - Inspect at every flight and at condition inspection. Replace with 1/8" pipe plug and install Hour Meter Relay Assembly (RANS P/N KAES0016) if leaks or defects are found.
