**Airworthiness Directive: 106**

**Subject: S-12 Tail boom Extension**

**Models Effected: S-12, shipped before 1/1/1991**

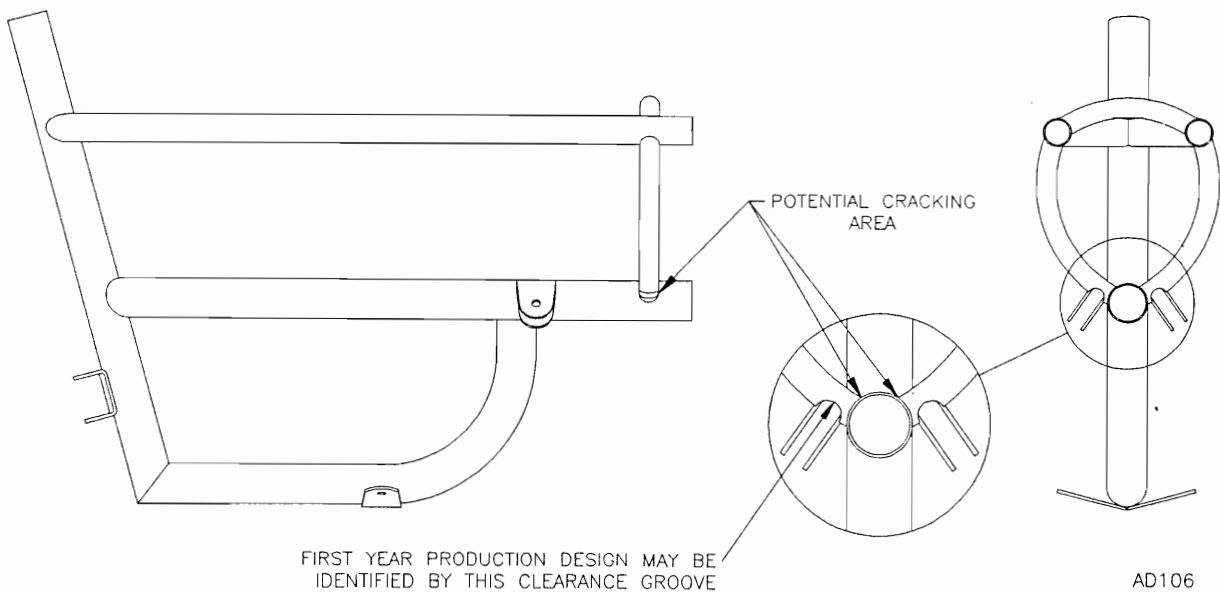
Figure 1

The first year production of the S-12 model had a different tail boom extension design than the current production design. In a survey done by RANS, Inc. on the S-12 model with a substantial amount of time accumulated on the air frame, a total of 2 aircraft with the first year boom extension design had a crack in the tail boom extension ( see Fig 1.) Because of the fail safe design of the boom extension, no problems were detected in flight.

The tail boom extension on the first year production should be inspected after 300 hours, if a crack is found, then the boom extension should be replaced. If no cracks were found then the inspection should be done every 50 hrs.
