**Airworthiness Directive: 105**

**Date: 6/22/93**

**Subject: *Bellcrank gusset***

**Models Effected: *S-6ES, S-12, S-14 shipped after 6/20/92***

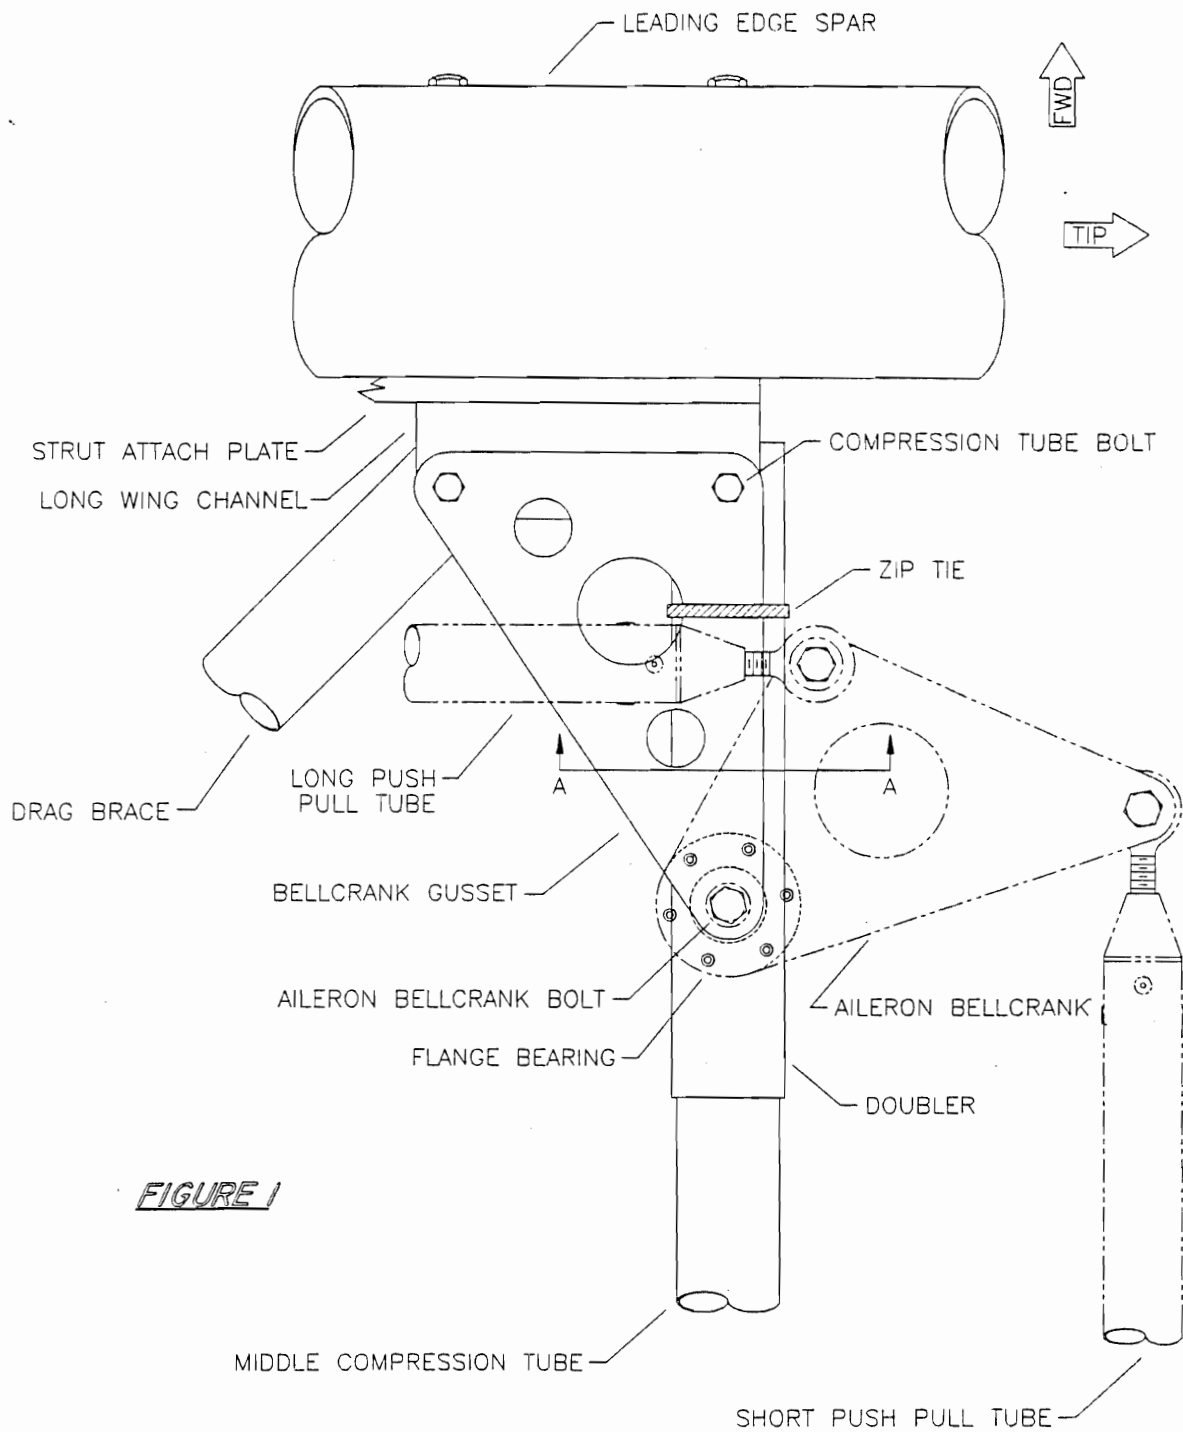
**FIGURE 1**

Improper assembly of the bellcrank gusset (CS-BELGU-LH/RH) may result in jamming the aileron. The gusset will have a tendency to bow upward if forced to fit between the compression tube and aileron bellcrank bolt. Proper assembly has the 1/4" hole drilled into the gusset by transfer once in place. To assure against aileron jam by gusset interfering, a plastic zip tie can be installed as per figure 1. and prescribed procedure below.

1. Unzip the inspection port closest to the aileron bellcrank and inspect the gusset.
2. Detach the aileron push pull tube from both ends.  
(HINT: count the number of turns when detaching the push pull tube so that you don't have to rig the aileron again when reinstalling.)
3. Get one mid size zip tie.
4. Pass your hands through the aileron push pull tube opening and the inspection port.
5. Pass the tie wrap around the compression tube through the hole over the bellcrank gusset, BUT UNDER the bellcrank (see figure1.)
6. Secure the tie wrap in place and cut the access so that it will not interfere with the aileron operation. Make sure that the tie wrap locking mechanism is pointing down.
7. Reinstall the aileron push-pull tube
8. Verify that the aileron moves freely with no restrictions.
9. Zip close the inspection port.

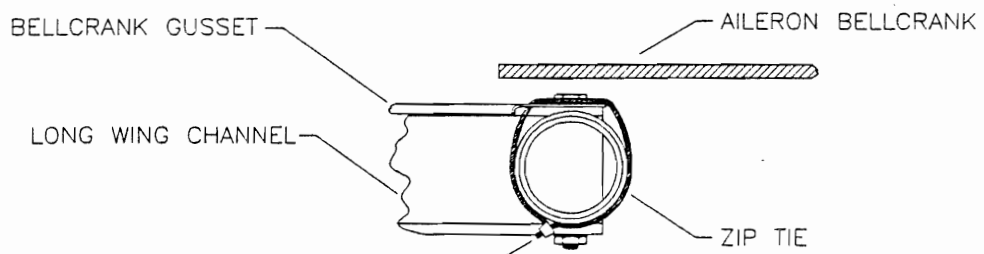
**VIEW A-A**

NOTE: POSITION OF NYLON TIE WRAP LOCKING MECHANISM ON LOWER SIDE OF TUBE
