RANS

Assembly Alert: 183
Date: March 16, 2018
Subject: Relieve cut in wing root ribs
Compliance: Mandatory
Models Affected: All 141 wings under construction.
Cost: No Charge

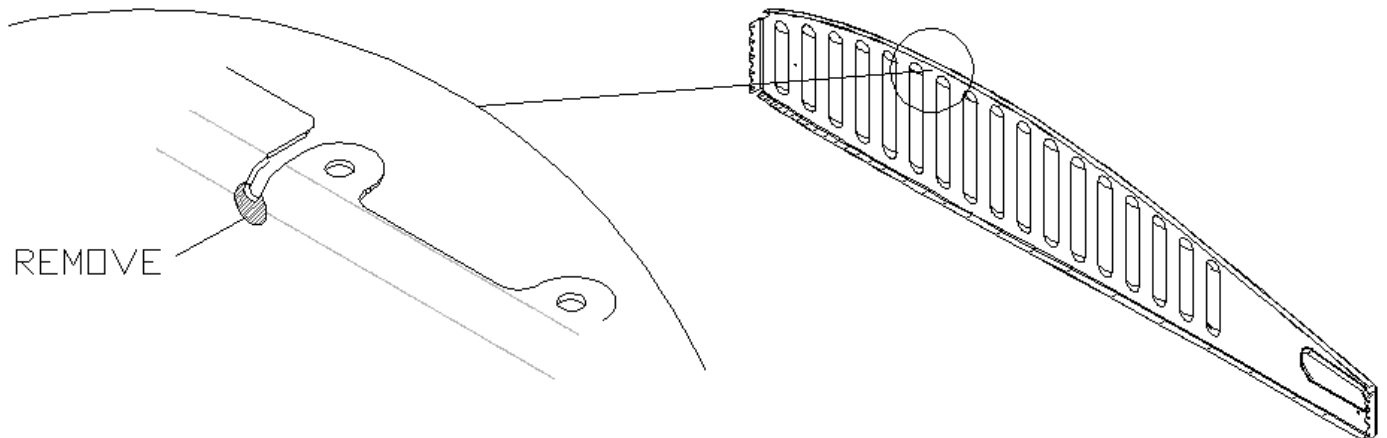
It has come to our attention that the relief next to the micro flange on the top front section of the wing root ribs is inadequate and causes cracking during the forming process.

The parts that require inspection and modification are KPWI0639 and KPWI0640.

Each builder should inspect the root ribs. Use a 3/16" to 1/4" drill bit to remove material as shown. Deburr and remove more material as necessary to remove any visible cracks. If the top skin is already riveted to the ribs, the problem area on KPWI0640 can be inspected and repaired through the root of the wing after removing the inside root rib and wing tank.
