RANS

Airworthiness Directive: 131

Subject: Tail Boom

Models Effected: All S-12 Airailes with Serial Numbers Before 01950000

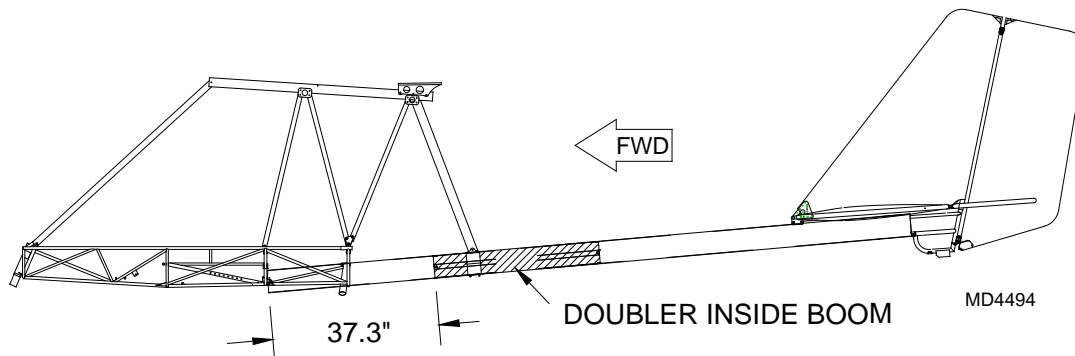
- A. Installation of the tail boom doubler sleeve. Inspect the inside of the boom to visually confirm the presence of a boom doubler sleeve. If there is not a boom doubler sleeve present, the aircraft is to be grounded and the boom replaced with a tail boom with the doubler sleeve. Flight is **not** recommended for any version of the Airaile aircraft **not** equipped with a boom doubler sleeve. The boom doubler sleeve can be viewed from the tail end of the boom using a powerful flashlight. See drawing below for location.
