RANS

Operational Alert: 162
Date: September 13, 2006
Subject: Aileron Link Cables and Turnbuckle
Compliance: Mandatory
Models Affected: All S-7LS and S-7S models

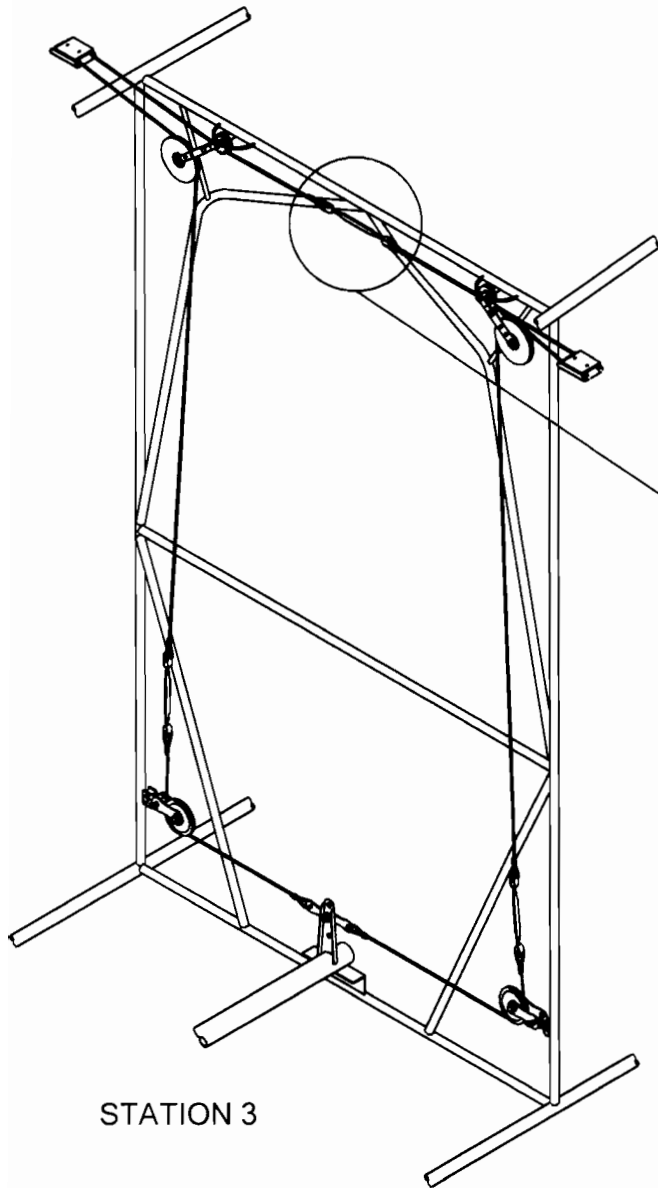
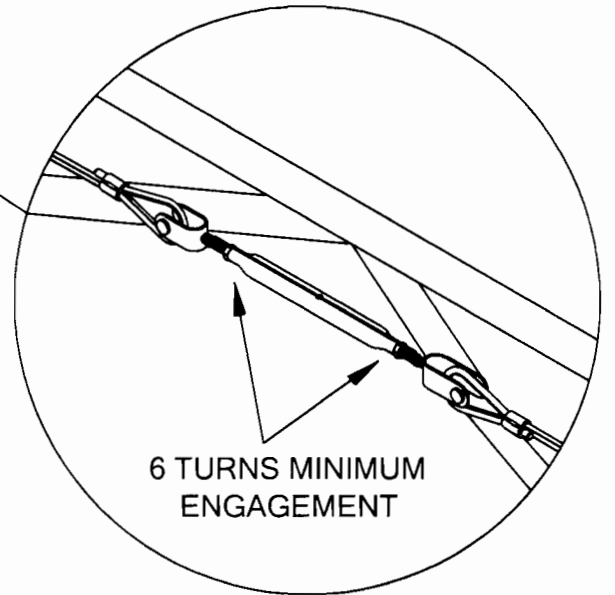
STATION 3

During assembly of an aircraft at the factory, we noted that only 4 threads could be engaged on the upper Turnbuckle at Station 3 (connecting Aileron Link Cables). Investigation showed that some Aileron Link Cables have been made too short.

A minimum of 6 threads should be engaged on each end of the Turnbuckle.

6 TURNS MINIMUM
ENGAGEMENT

Prior to the next flight, inspect upper Turnbuckle at Station 3 for thread engagement (Reference attached drawing).

If this cannot be assured, change Turnbuckle to part # RL-335-BT. Turnbuckle RL-335-BT is slightly longer and available from RANS Parts Department.

Refer to manual for proper rigging.
Safety wire turnbuckle after inspection, check for clearance or interference with other parts.
Perform functional check of ailerons before flight.

TURNBUCKLE IS RL-335-AT
CHANGE TO RL-335-BT
IF REQUIRED.
