Assembly Alert: 190

Date: September 10, 2019

Subject: Installation of correct count of rivets and other hardware

Models Affected: S-21 OUTBOUND

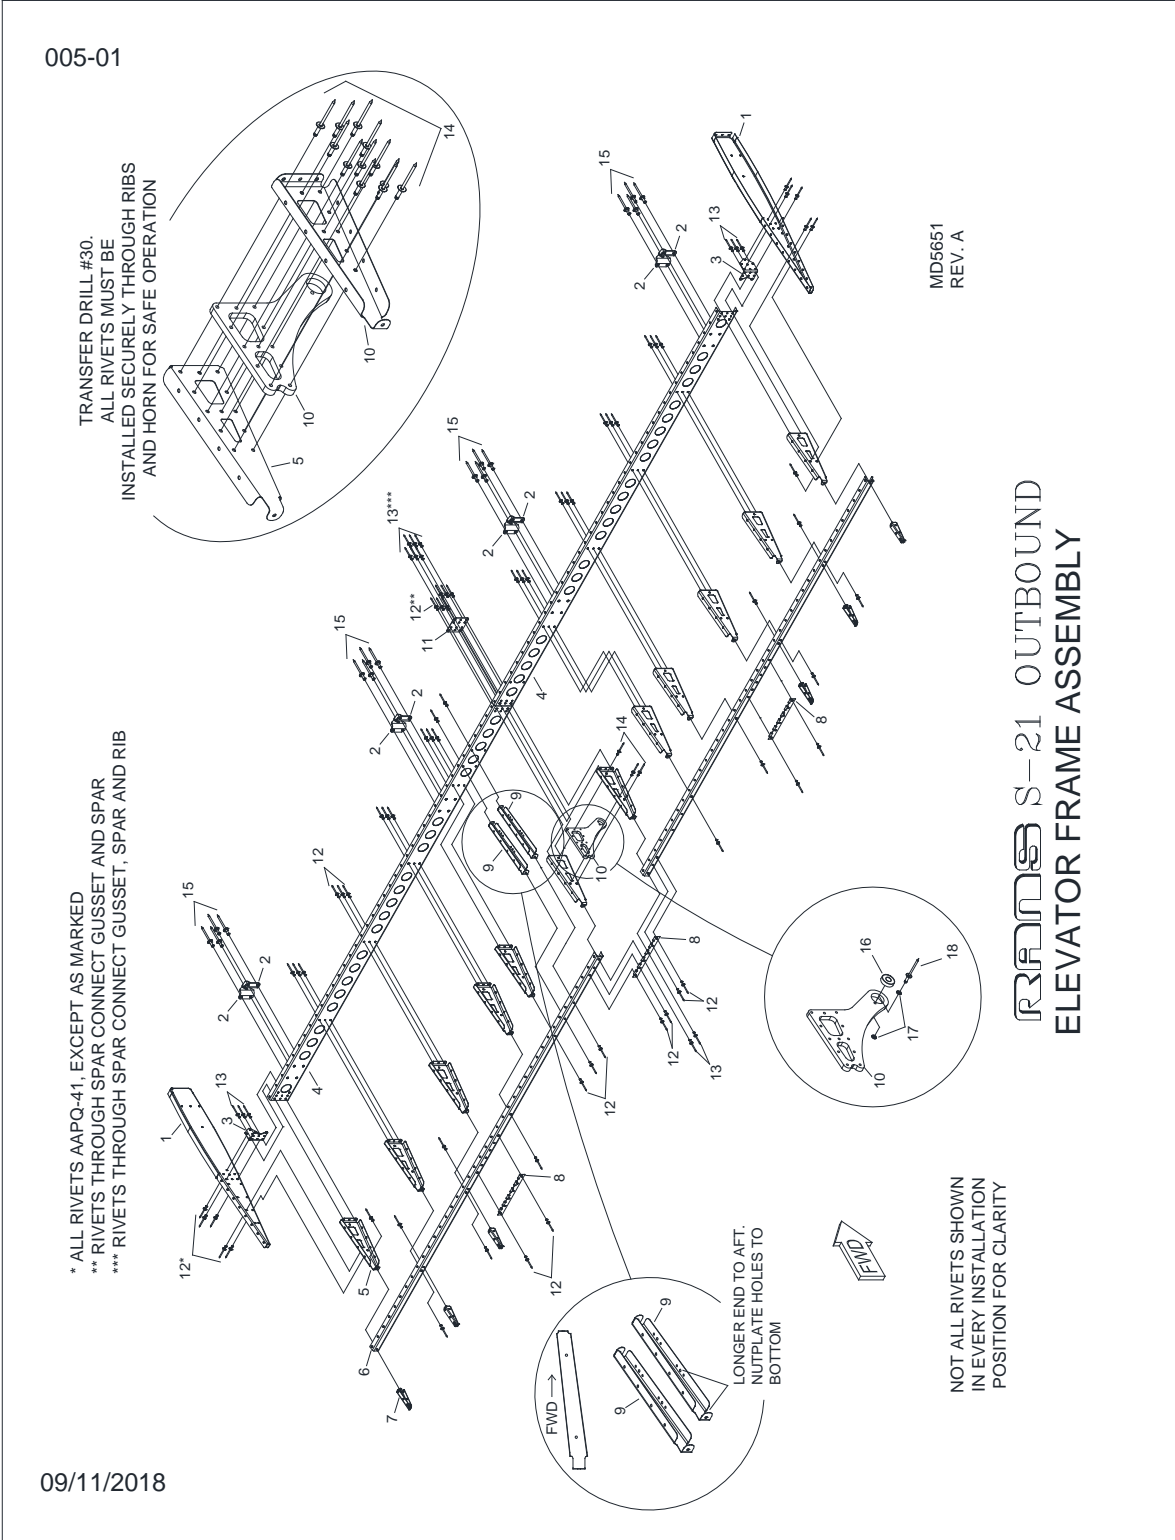
Refer to **Parts Page 005-01 Rev. A** below for more detail. Please note that not all rivets or hardware is shown for every installation position for drawing clarity.

During inspection of a builder assembled elevator frame, prior to installing the skin, it was noted only three (3) rivets were used to attach the elevator horn to the elevator ribs.

In the text it clearly states to transfer drill the additional holes that are provided in the elevator horn for a total of twelve (12) rivets to retain the elevator horn.

This is critical for the security of the elevator and control of the aircraft. Please inspect your elevator horn/rib assembly, as well as all assemblies, for proper rivet/hardware type and count prior to installation of the skin.
