ASSEMBLY ALERT: #138

SUBJECT: WING - LEADING EDGE RIVETS

MODELS AFFECTED: S-16

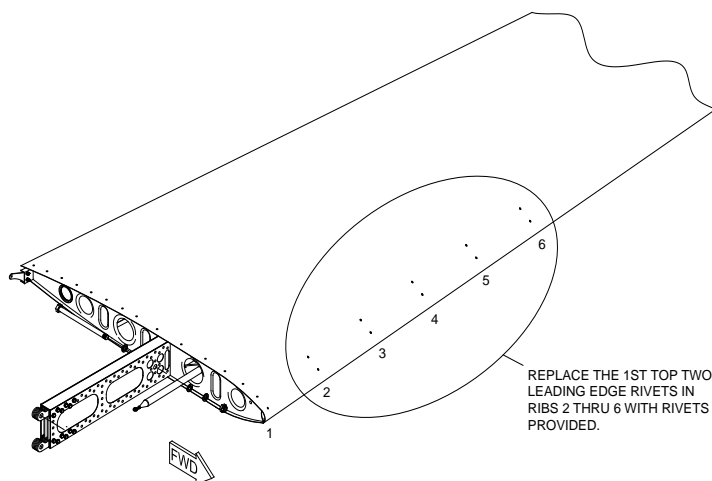
FIGURE AA-#138

NOTE: Assembly alert applies to forward ribs #2 thru #6.

Three (3) leading edge rivets on each wing on our S-16 prototype have loosened. This is due to two (2) factors.

1. Our prototype uses .020 leading edge skins.
2. Rivets were not set properly and a gap resulted between skin and rib.

To prevent this from happening on your aircraft we recommend replacing the rivets (see Figure AA-#138) with CherryMax rivets (CR3213-41). These rivets will be shipped when in stock.
