AIRWORTHNESS DIRECTIVE: 103

SUBJECT: S-7 582 ENGINE MOUNT

MODELS EFFECTED: S-7 COURIER

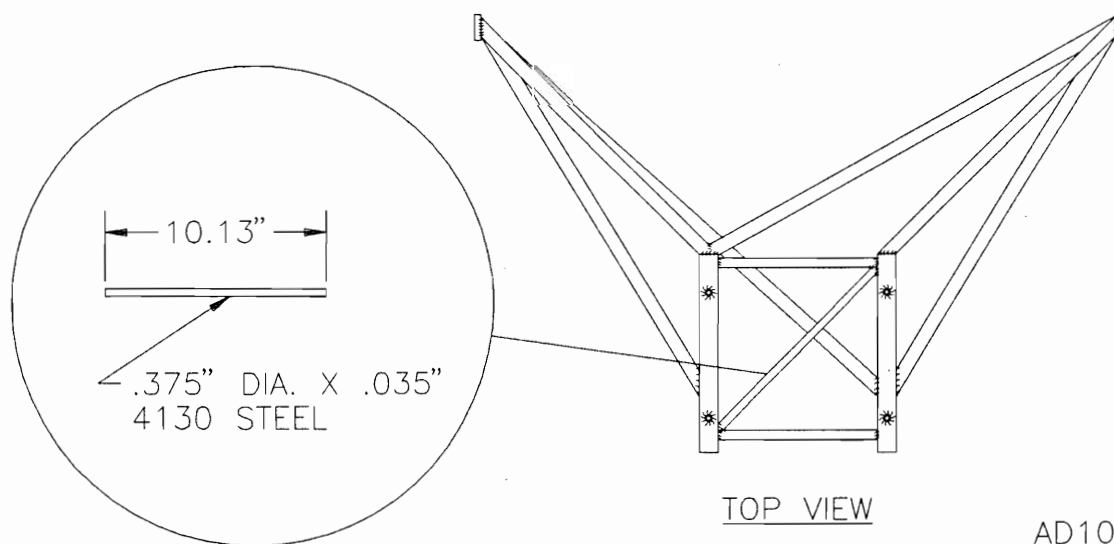
AD103

S-7 COURIER's with 582 engines must have their engine mounts inspected for cracks at the inside four corners of the engine mount bed. The engine mount may have a diagonal chromolly tube across the engine bed. if this tube is not there you must repair this with one of the three options below.

1. Trim the cromolly tubing to closely fit the inside corners diagonally.
2. Weld the tubing in place (TIG or OXY/ACETYLENE WELDING is reccomended).
3. Paint to suit.
