RAMS

Airworthiness Directive: 127

Subject: Trim Tab Flutter

Models Effected: All S-7 Models Manufactured Before 1999

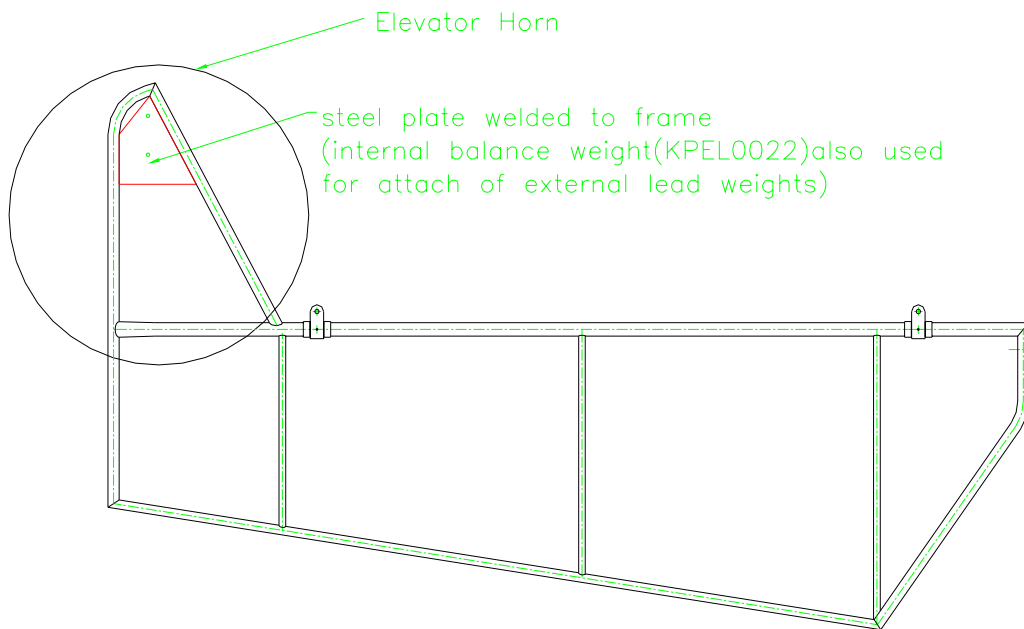
This will be easy on all elevators built after 97. These elevators have already a heavy steel plate welded in the tip of the horn to achieve some degree of balance and to attach the external lead weights.

The drawing below shows an elevator with horn and internal weight installed.

If your elevators have these plates installed (feel through the fabric) you can simply follow the enclosed instructions for mass balancing.

If your elevator does not have the internal steel plates (Manufactured in 97 and before), we suggest installing them (Spot weld in 5 places). The plates will be available through the factory (Order: Mass balance KPEL0022). You will need two.

The plates have to be flush with the lower surface of the elevators.

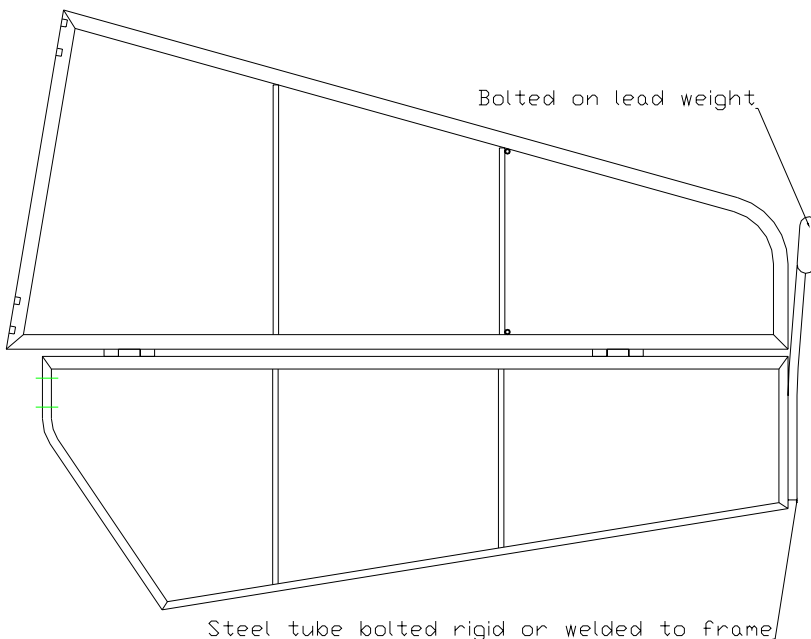
The new tail does not fit these older airplanes.
The following is suggested:

Mass balance both elevators to the hinge line. The elevators have no horn to attach a weight. We suggest attaching a forward facing tube to the outside of the elevator for the weight attach. The tube needs to be rigid enough to support the weight and must be bent outward to clear the horizontal stab during elevator movement. Bolt or weld on tube to elevator frame. Refer to picture below for the general lay out. Also change the trim system to eliminate the spring or fix trim tab rigid in position.
