Assembly Alert: 192

Subject: Missing Seat Bottom Tube

RANS
SEAT TUBE PLACEMENT AND SEAT FLAP ROUTING
ASSEMBLY ALERT 192

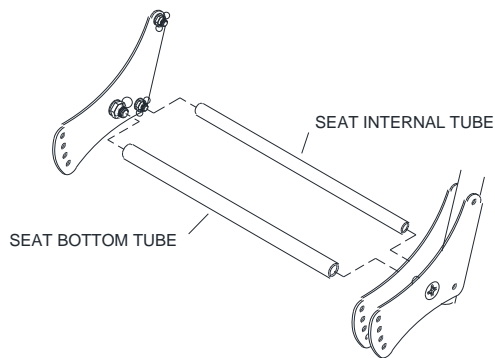
SEAT TUBE PLACEMENT

We have discovered the revised seat assembly is lacking technical information on assembly using a 5/8" tube (Seat Bottom Tube – KPST0135) that is used to secure the aft edge of the seat bottom. If you already have your seat assembled minus this tube, it may be added without taking apart the seat.

1. Remove Seat Frame from Fuselage.
2. If Seat Bottom Cushion is installed, pull it forward as far as possible to allow seat frame to flex.
3. Check length of both tubes (Seat Bottom Tube & Seat Internal Tube) to be sure they are of equal lengths. Trim the longer tube to match the shorter tube.
4. Spread Seat Frame until Seat Bottom Tube can slip over the 1/4" Shear Nut.
5. Install Seat Bottom Tube and Seat Internal Tube. Be sure Aft Flap of Seat Back Cushion is captured by the Seat Internal Tube.
6. Pull Upper Flap around Seat Bottom Tube until Velcro overlaps evenly half-way onto AFT end of Velcro on seat bottom.
7. Pull FWD Flap under Upper Flap and secure to FWD end of Velcro on seat bottom.
8. Re-install Seat Frame in Fuselage.
