Assembly Alert: 191

Date: October 8, 2019

Subject: Trimming of Inner Wing Rib to clear Lower Wing Stringer

Models Affected: S-20 RAVEN with 141 Wing with Wing Stringers KPFU0743
S-21 OUTBOUND with Wing Stringers KPFU0743

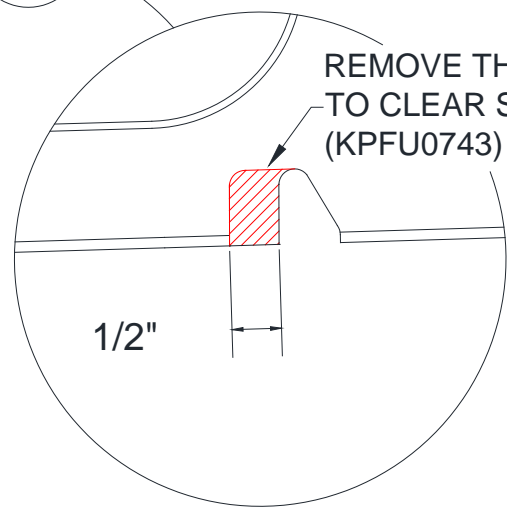
INNER WING RIB
(KPWI0638)

During building of a 141 wing, prior to installing the skin, it was noted that the rivet holes for attaching the Lower Wing Stringer (KPFU0743) to the skins were not aligned properly, fore and aft, with the cut-out in the Inner Wing Ribs (KPWI0638-L/R). The difference may be as much as 1/2".

REMOVE THIS AREA
TO CLEAR STRINGER
(KPFU0743)

1/2"

If it is found the Lower Wing Stringer does not align with the cut-out in the wing rib, then modify the rib per the drawing below to allow the stringer to clear.
