Airworthiness Directive: #113

Subject: 2-3 Longeron/Main Gear Brace Attach Point

Model Effected: S-4 Coyote I (Taildraggers)

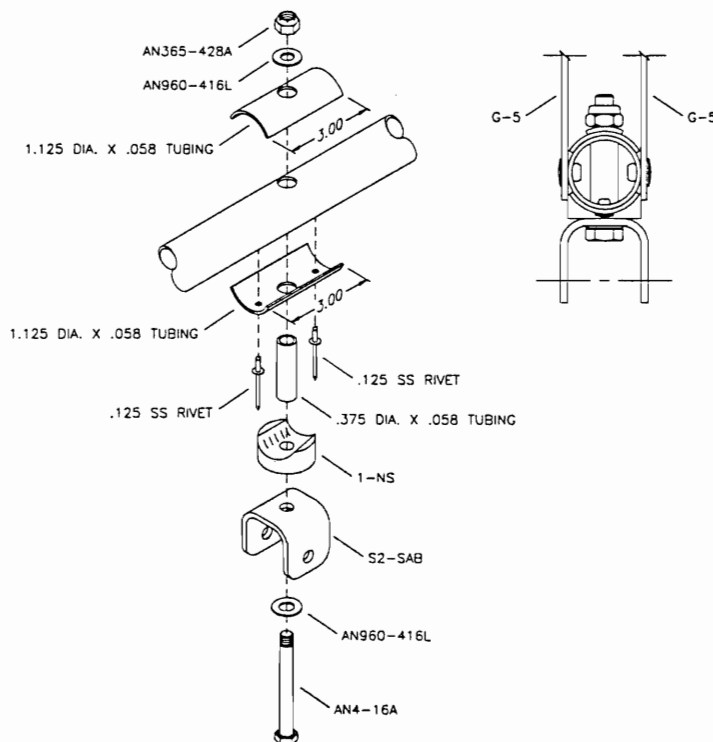
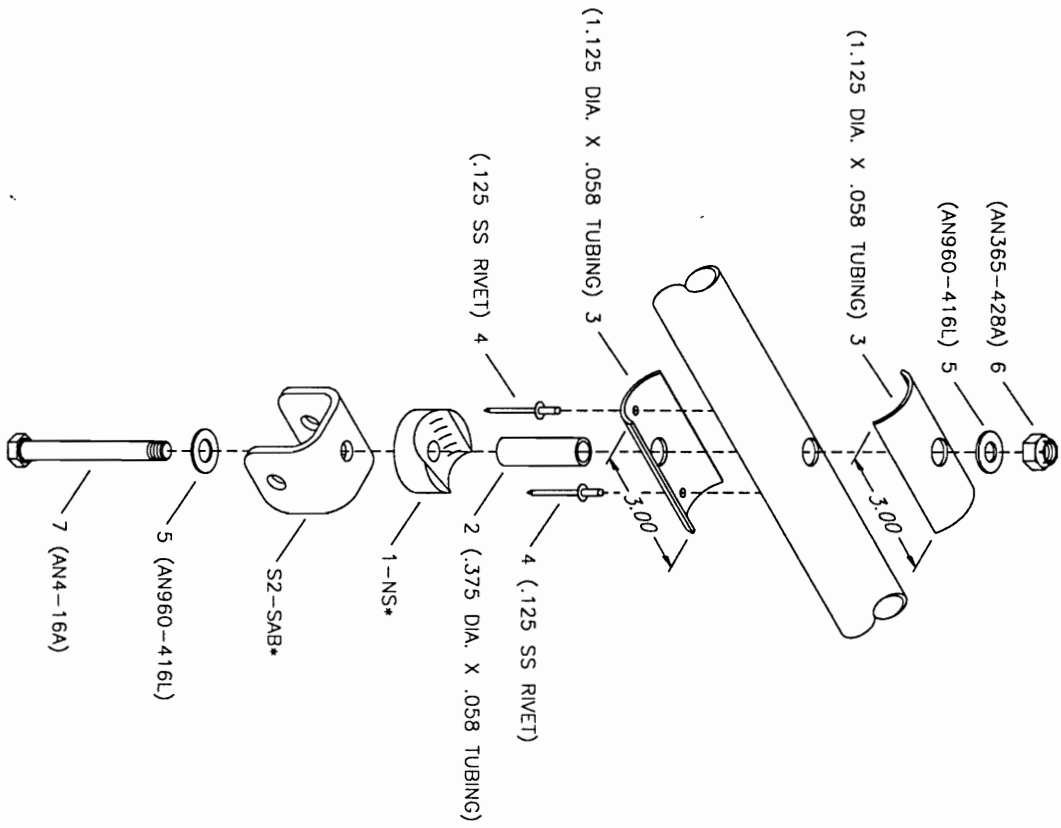
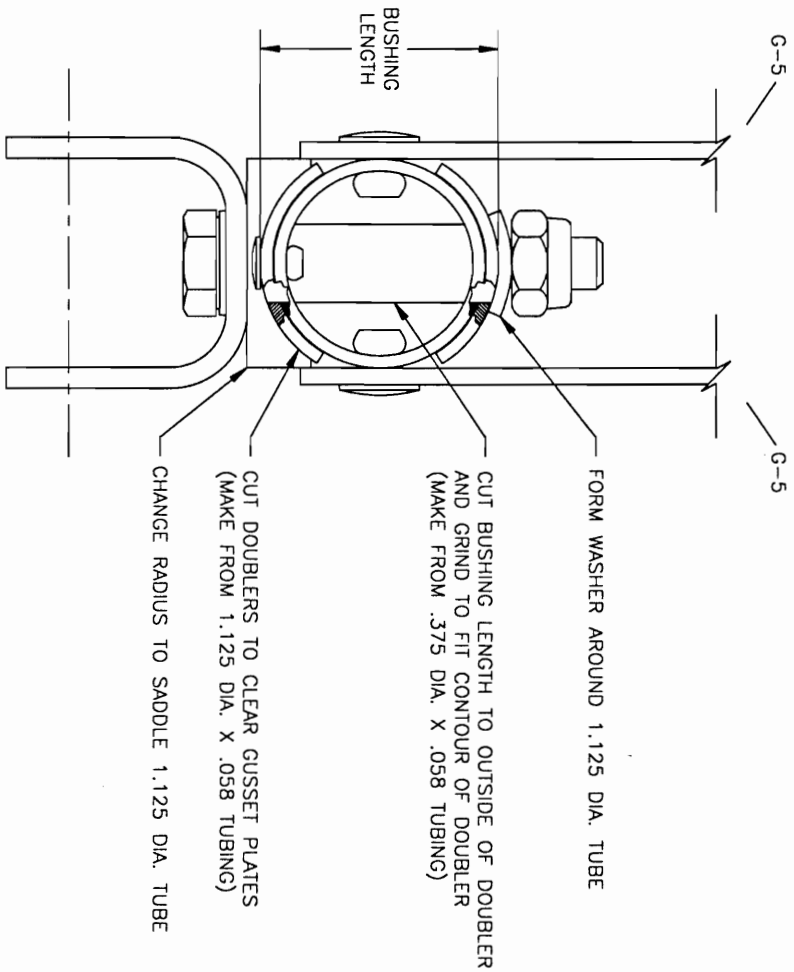
MD2531

The attachment point between the main gear brace and longeron (part # 2-3) connecting stations 2 and 3 on the S-4 is designed with an internal doubler. On some aircraft this doubler is missing. Without this doubler installed, the main gear brace attachment bolt could pull through the longeron. To correct this problem, one must first determine if the doubler in question is missing. Do so by supporting the aircraft by the struts where they attach to the wing. Hint: Two sturdy step ladders can be used. Remove the bolt retaining the aft gear brace to the longeron and inspect for the doubler. If the doubler is missing, please follow the recommended fix per the illustration below.

Note: The parts in the illustration can be ordered from the parts department. Ask for kit No: AD#113.
