# RANS

**Airworthiness Directive:** 140

**Subject:** Hour meter oil pressure switch leak

**Models Affected:** All RANS aircraft with ROTAX 912 series engines equipped with an oil pressure switch for hour meter

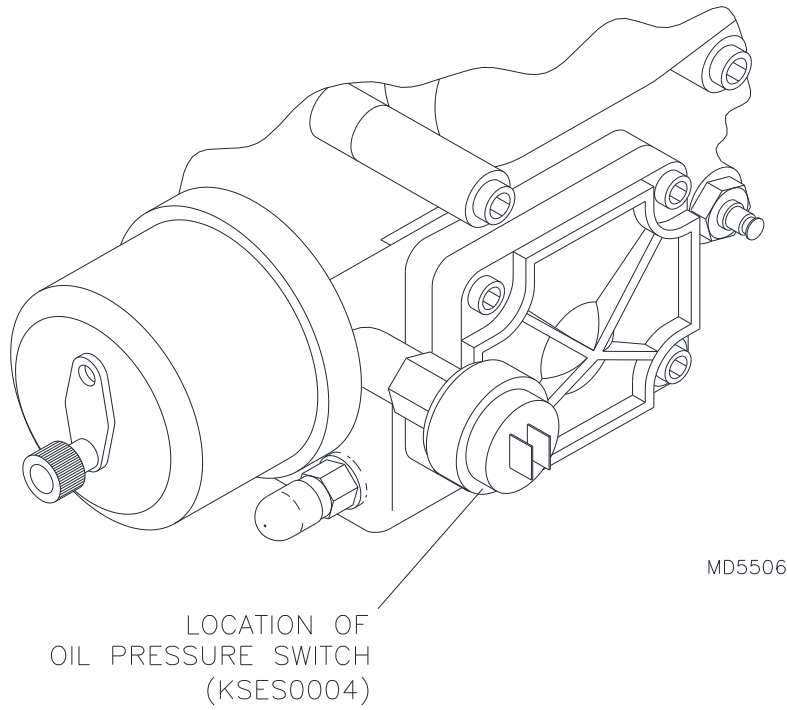
**Oil Pressure Switch Location:**

It has been brought to our attention that failures have occurred in the internal seal of the Oil Pressure Switch (RANS P/N KSES0004). This has caused premature loss of oil resulting in engine failure. Due to possible sudden failure of the Oil Pressure Switch the Hour Meter Relay and 1/8" Pipe Plug should be installed before next flight.

If the aircraft is equipped with Oil Pressure Switch (RANS P/N KSES0004), remove the aircraft from service until it is possible to replace the Oil Pressure Switch with an 1/8" pipe plug and install Hour Meter Relay Assembly.
