**Airworthiness Directive: #114**

**Date: January 10, 1997**

**Subject: Coyote II Skylight**

**Models Effected: S-6ES, S-6S, S-6XL, S-6SXL**

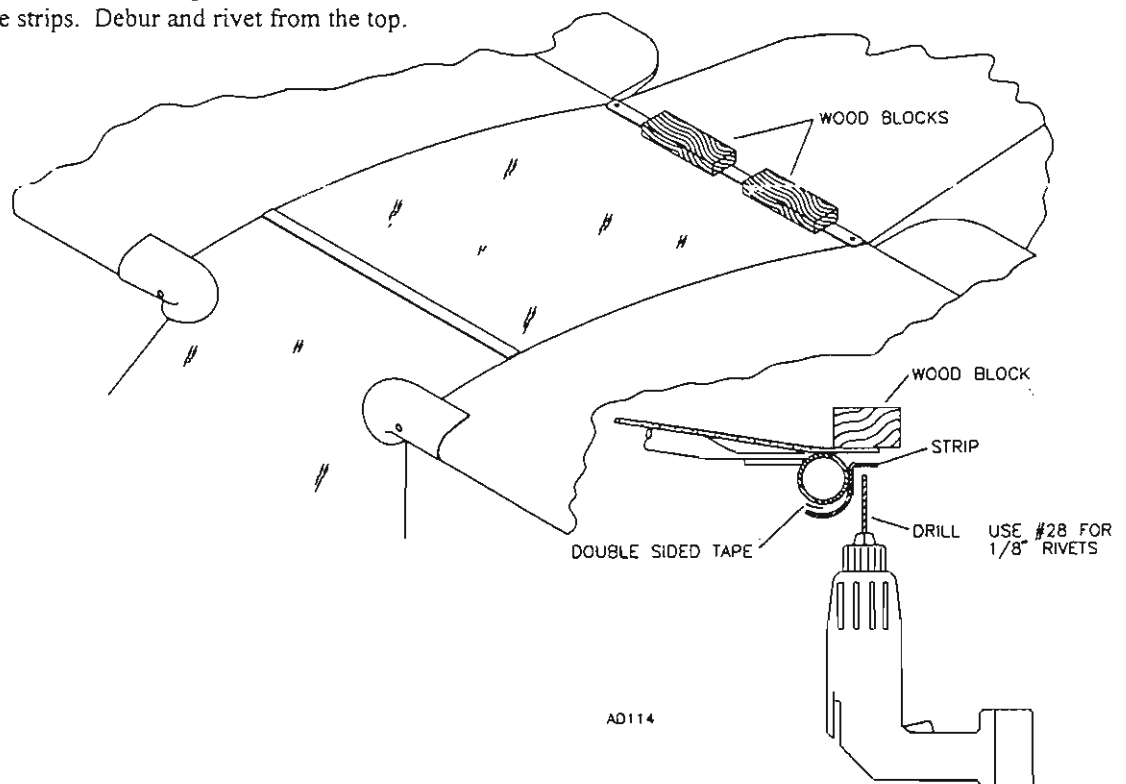
We have a report of one case of the aft rivets which retain the ribs on top of the cabin separating. Indefinite pitch control may result if seperation occurs. Pitch control can remain positive if speed is reduced.

- 1) Remove the seats and baggage compartments to gain access to the aft side of Station 3's upper crossing tube. Alternate: Access through the aft baggage or un-lace at bottom of the plane.
- 2) Place the two formed strips (KPWS0004) on each side of the top center stringer or dorsal fin leading edge in the S-6S or \S-6SXL. See the drawing below.
- 3) Drill up thru the strips. Deburr and rivet from the top.
