**Operation Alert #: 196 Rev A**

**ISSUE DATE: March 27, 2025 – Rev A**

**MODEL AFFECTED: S-20 & S-21 equipped w/ Whirlwind GA-200 series prop**

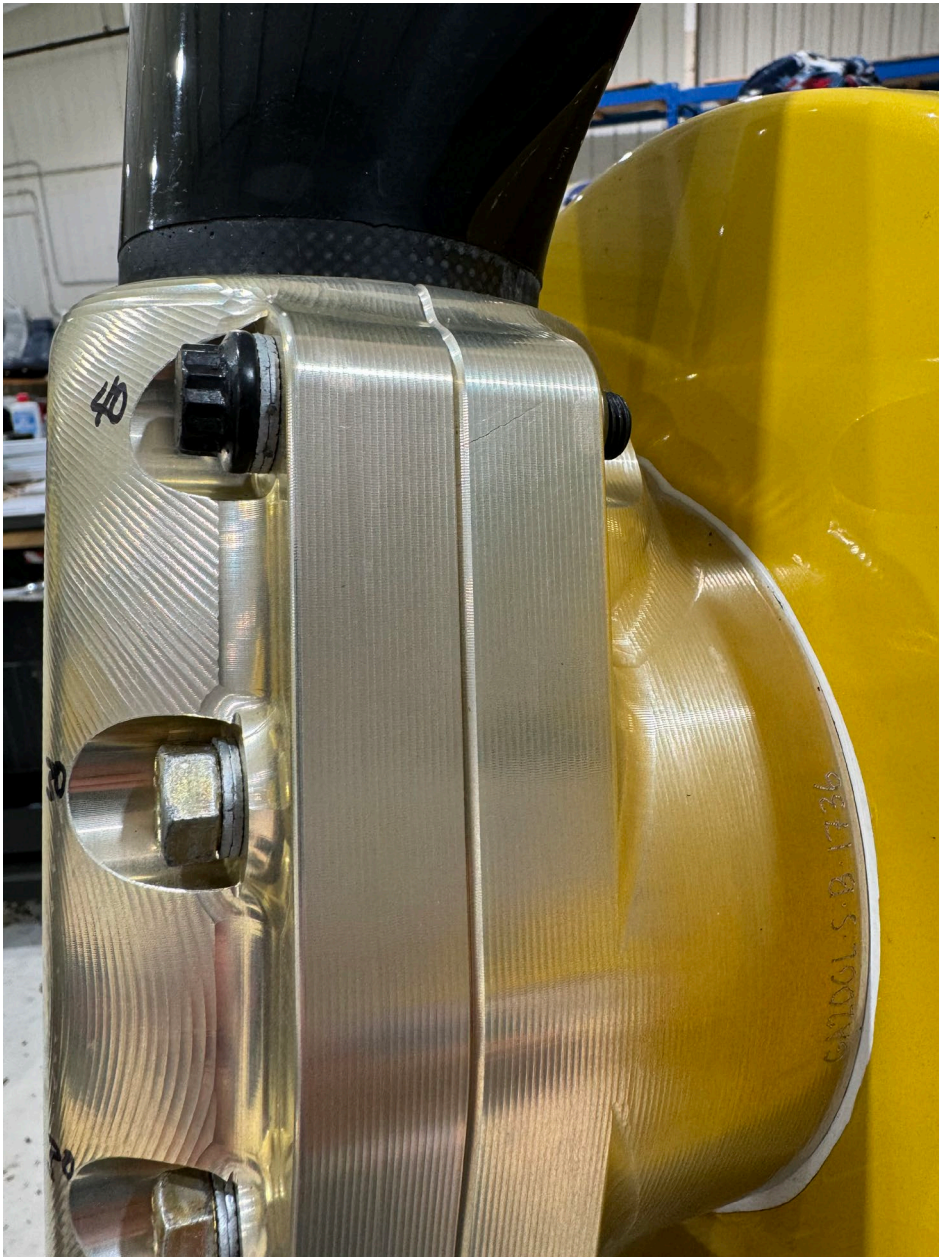
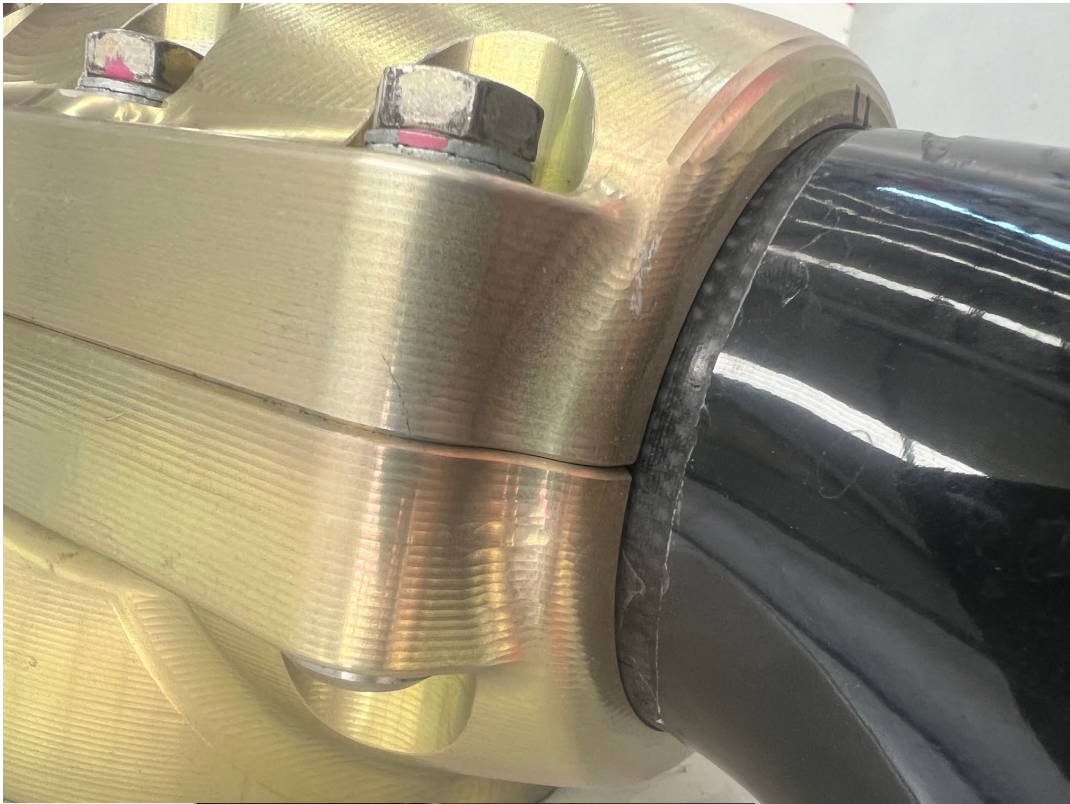
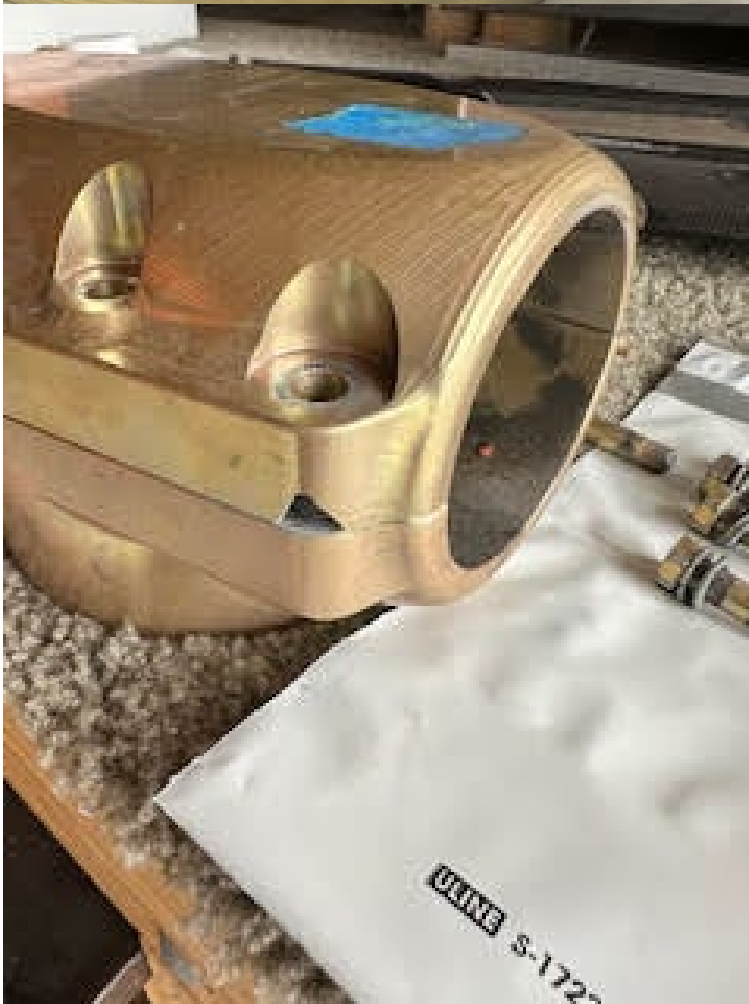
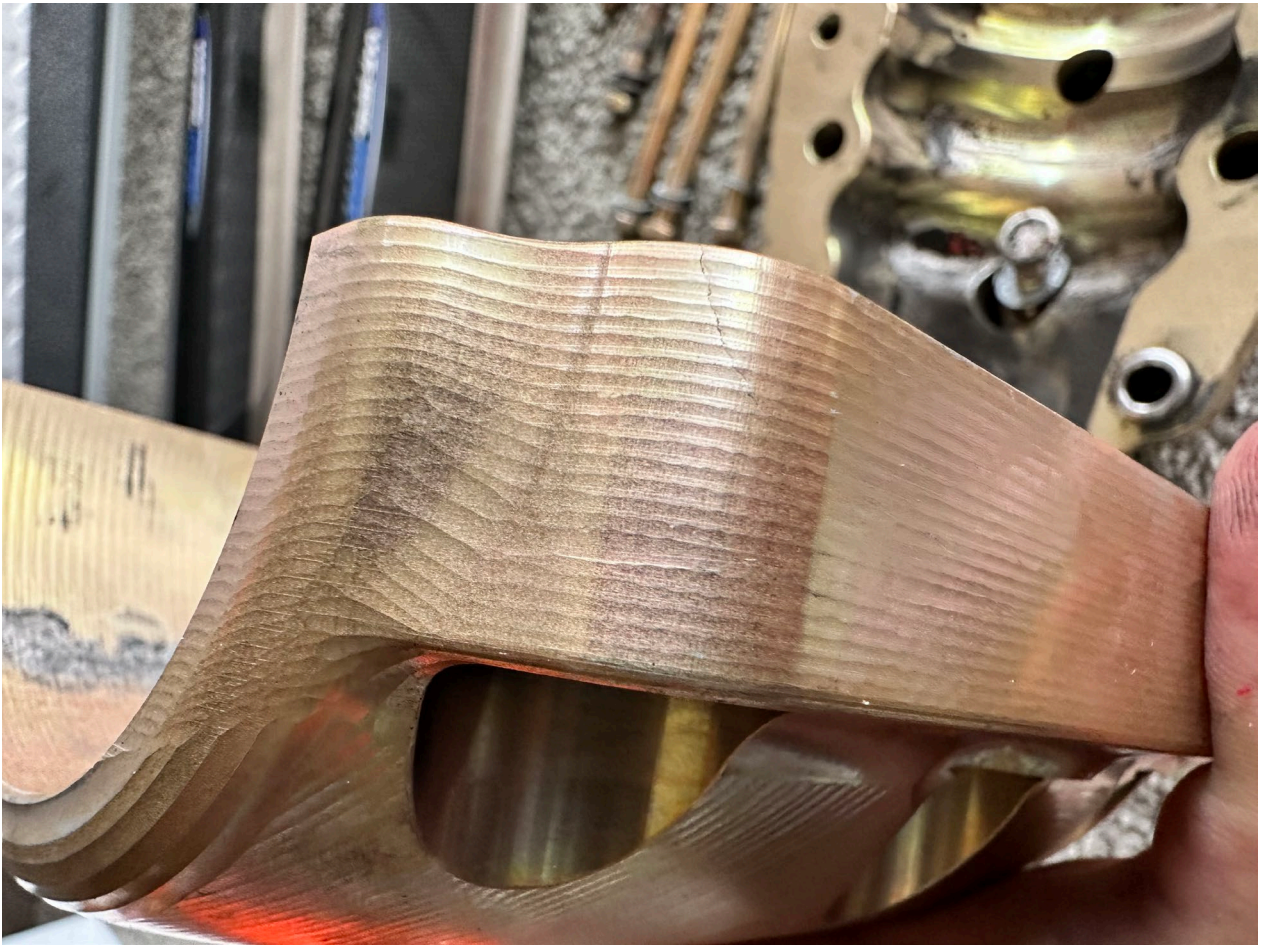
It has been reported on multiple occasions that the older style hub of the Whirlwind GA-200L – 616 - 2B has cracked at the root end of the hub. This particularly occurs next to the blade retention bolts. It has also been reported multiple times of bolts shearing. At this time, we are not aware of the newer style hubs having any cracks. The newer style hub has proper clearance between the hub halves when torqued and has larger 7/16" bolts for the prop retention bolts.

This images below depict a few different hub cracks found upon propeller inspections:

An Inspection of the propeller hub should be completed before your next flight. Inspection of the bolt torques should be completed also before your next flight. This shall include the bolt torque of the two inner bolts that hold the hub to the prop spacer. There can be a crack that is hard to see, if there is a suspected crack, dye penetrant can be used to confirm a hairline crack. If any cracks are found, please contact Hartzell and RANS Designs Inc. and do not fly your airplane until the hub is replaced. If any sheared bolts are found, please contact Hartzell for replacements as well.
