Airworthiness Directive: 136

Date: May 14, 2010

Subject: Hour meter oil pressure switch leak

Models Affected: All RANS aircraft with ROTAX 912 engines equipped with an oil pressure switch for hour meter

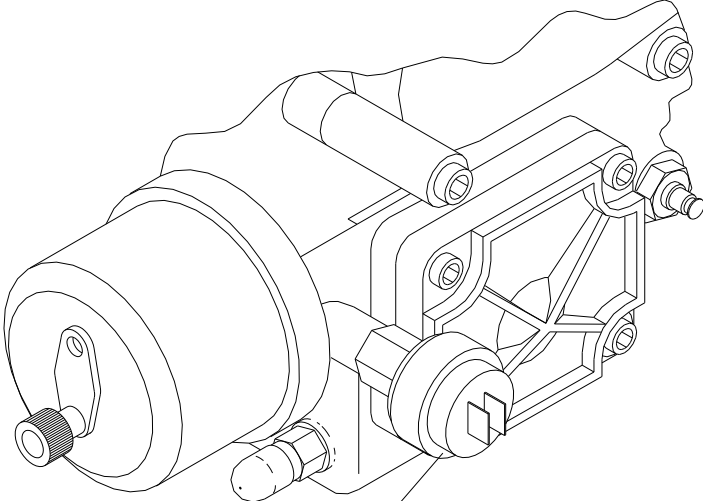
Inspection Location:

It has been brought to our attention that failures have occurred in the internal seal of the Oil Pressure Switch (RANS P/N KSES0004). This has caused premature loss of oil resulting in engine failure.

INSPECT FOR OIL LEAK HERE

Inspect for leaks before next flight. If leaks or defects are found, remove the aircraft from service until it is possible to replace the oil pressure switch with a 1/8" pipe plug and install Hour Meter Relay Assembly.
