Assembly Alert: 145

Date: November 15, 2000

Subject: Warp Drive Prop

Models Effected: S-16 Shekari, IO-240 equipped models

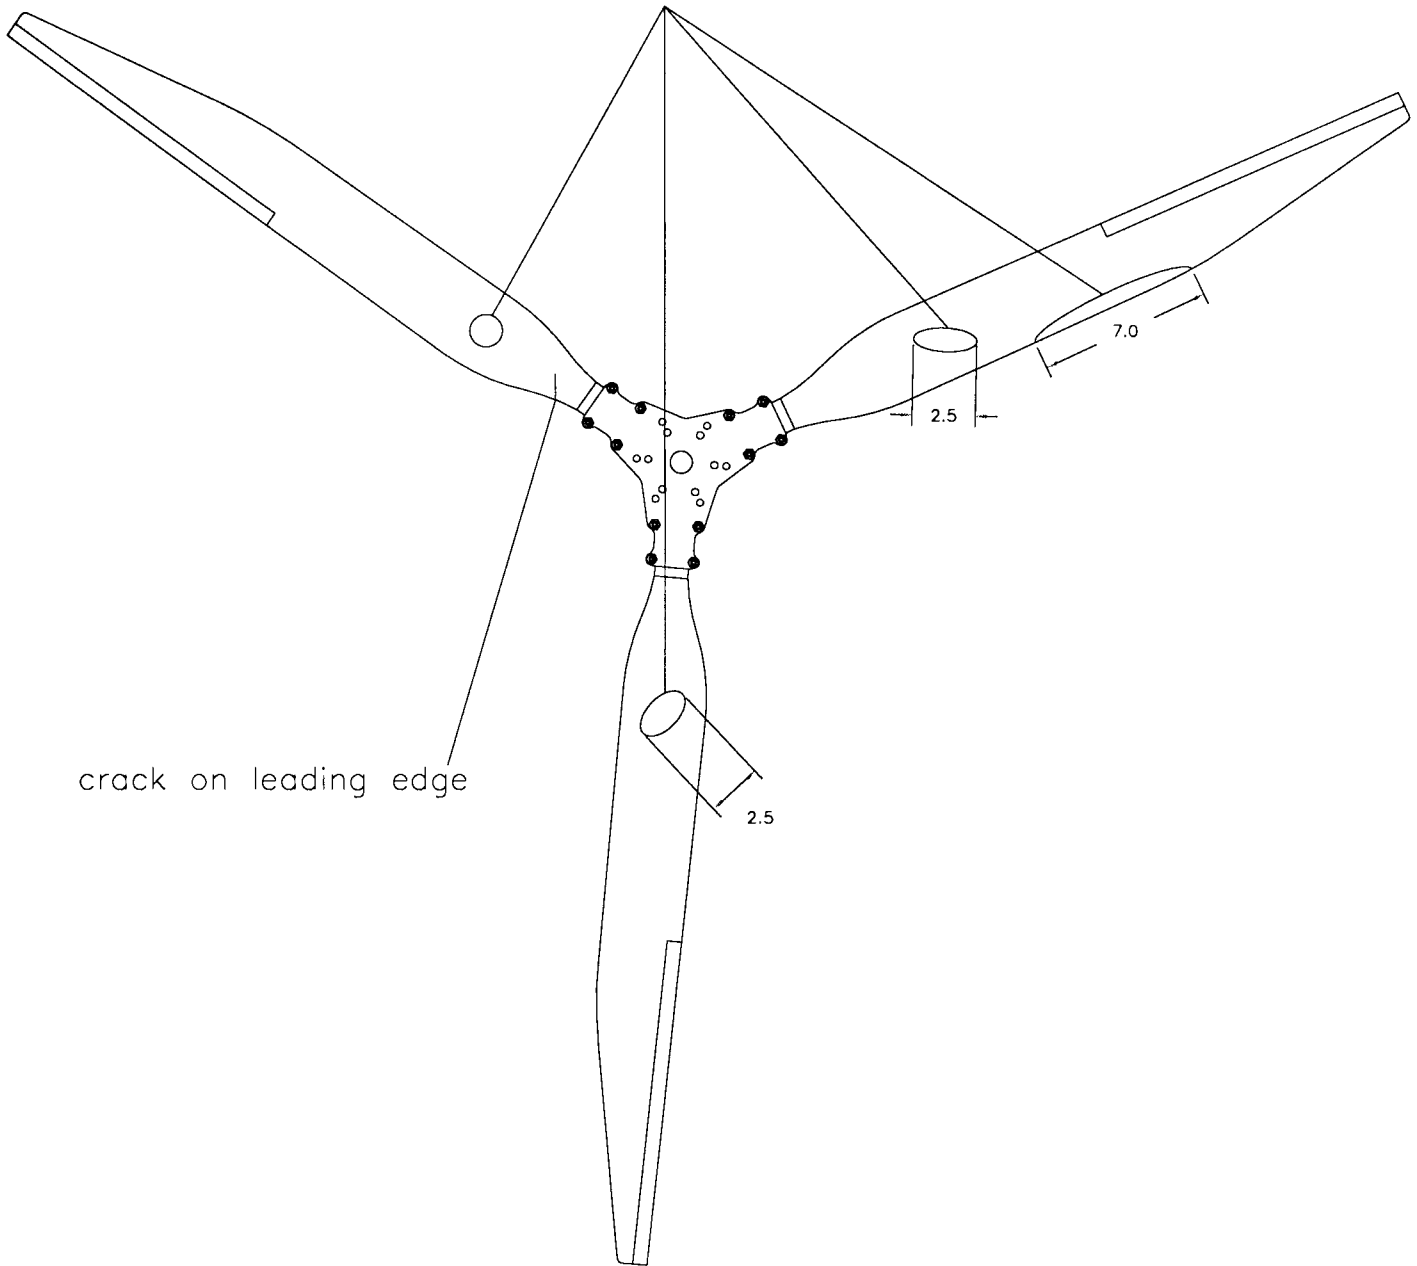
After 200 plus hours of flight time de-lamination and cracking of the three-blade Warp Drive prop has occurred in the factory demo plane. Our recommendation is to stop use of the Warp Drive prop and replace both the spinner and prop.

Areas of delaminating found on our factory demonstrator

3 blade 72" dia. tapered
on RANS S-16 factory AC
with 200 hrs. since new.
Engine Continental IO-240
(125 HP)

Pitch
13.2deg.
on tip

areas of delaminating

We are testing a two-blade Sensenich wood prop. This and a new metal spinner with forward bulkhead will be provided to owners with the current spinner and three-blade prop. The cost to the customer will be the difference in cost of the new items. Please return your spinner and prop for credit toward the new prop. Estimated cost to exchange is \$175 to \$200. The added performance increase over the three-blade Warp Drive prop should more than out weigh the increased cost.
