Assembly Alert: 191

Date: October 8, 2019

Subject: Trimming of Inner Wing Rib to clear Lower Wing Stringer

Models Affected: S-20 RAVEN with 141 Wing with Wing Stringers KPFU0743
S-21 OUTBOUND with Wing Stringers KPFU0743

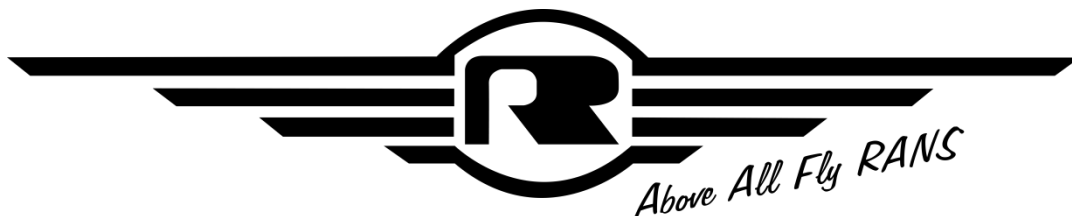
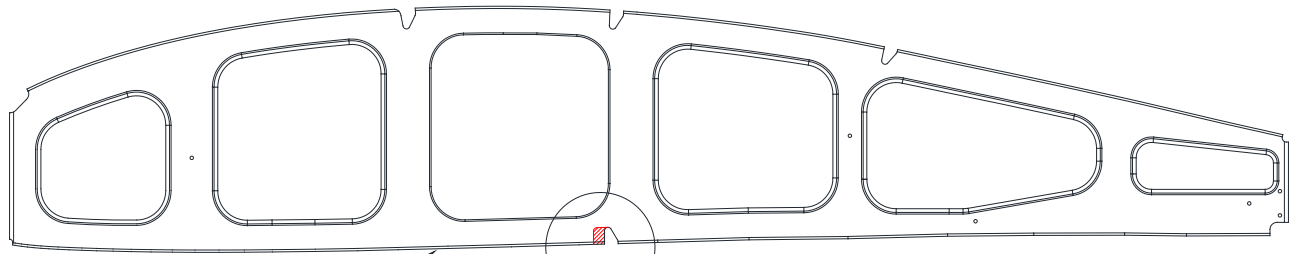
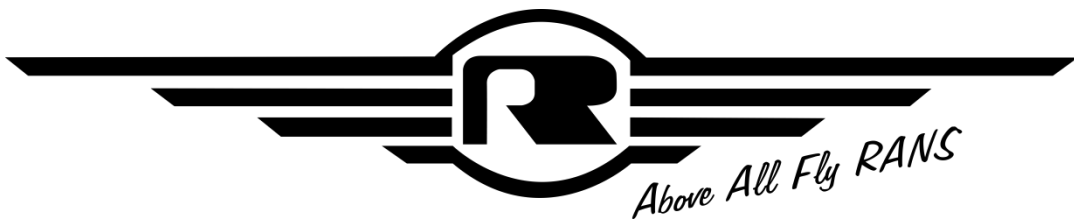
INNER WING RIB
(KPWI0638)

During building of a 141 wing, prior to installing the skin, it was noted that the rivet holes for attaching the Lower Wing Stringer (KPFU0743) to the skins were not aligned properly, fore and aft, with the cut-out in the Inner Wing Ribs (KPWI0638-L/R). The difference may be as much as 1/2".

If it is found the Lower Wing Stringer does not align with the cut-out in the wing rib, then modify the rib per the drawing below to allow the stringer to clear.

REMOVE THIS AREA
TO CLEAR STRINGER
(KPFU0743)

1/2"
