RANS

Assembly Alert: 169

Subject: Fuel tank inspection

Models Affected: S-19

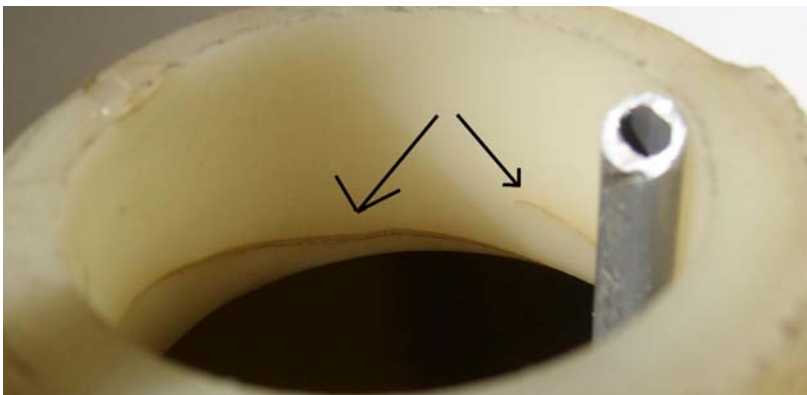
One builder of the S-19 has reported cracks around the base of the filler neck in one tank. Please inspect your tanks closely. The cracks in the photo appeared after leak testing and the dye in the fuel made them more apparent. Spotting cracks on tanks that have never been filled may require good lighting and a magnifying glass. Please inspect your tanks before and after installation, and periodically thereafter. Avoid inserting fuel nozzles into the tank and not supporting them, as this may cause cracking of the filler neck.
