RANS

Airworthiness Directive: 141
Date: January 24, 2022
Subject: S-21 and S-21LS Nose Gear Strut
Compliance: Mandatory
Models Affected: S-21, S-21LS Outbound model with TRIKE landing gear

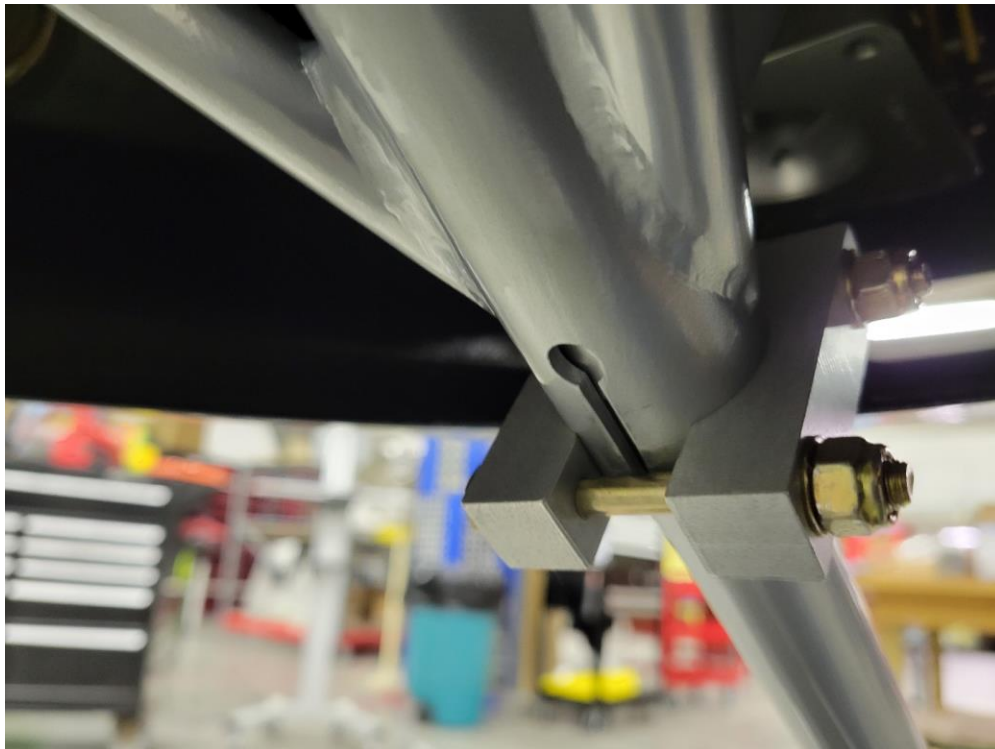
5. If a slot is not present at the end of the nose gear socket: Remove nose gear strut. Mark on the top and bottom and center punch 1 1/2" from the bottom edge. Drill 1/4" then using a thin blade (.125") cut off disc, slot to the drilled holes. See photo below.
6. Remove burrs and touch up cut areas with primer/paint.
7. Install the 3/8" bolt and torque to 200-250 inch pounds.
8. Remove the existing U clamp and re-install using the second saddle and the (2) AN4-23A bolts. Position the clamp assembly so the bolts are horizontal allowing the clamp to squeeze the end of the nose gear socket. Torque to 80-100 inch pounds.
9. Check all bolts for proper torque every condition inspection.

1. Set park brake and secure the tail so the nose gear is lifted a couple of inches off the ground.
2. Remove cowlings
3. Check security of the lower U clamp. This needs to be tight so the gear leg will not shift during drilling and reaming.
4. Remove the 1/4" bolt and drill and ream to fit the provided high tolerance 3/8" bolt.
